IJCRO 2021; 3(1): 91-92

Unwinding of a 4.5 mm partially threaded cannulated screw in an elderly patient: A case report

Michael Booth MD and George Bal MD

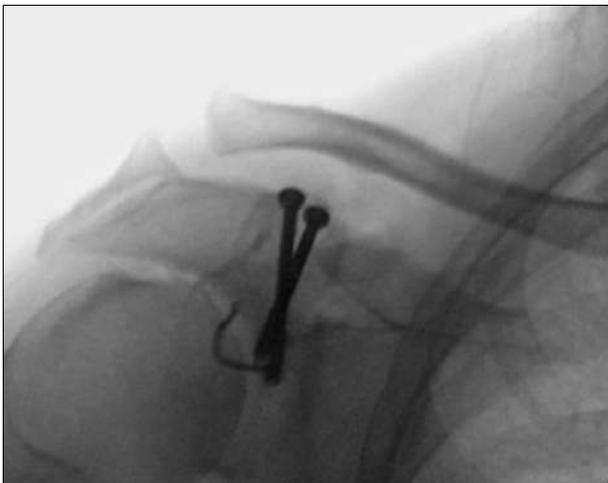
Under anesthesia, the fracture was reduced using a point reduction clamp and a guidewire was placed through the medial base of the coracoid. A 4.5 mm x 46 mm long partially threaded cannulated screw was placed over the guidewire and inserted without any issues. A second guidewire was placed lateral to the first screw through the coracoid and an additional 4.5 mm x 68 mm long screw was inserted over top of the guidewire. When we checked our screw position on x-ray, it was revealed that the second screw had unraveled leaving a ribboned piece embedded in bone (figure 2). No increase in resistance was felt during the insertion of the defective screw. The drill bits and guidewires for both screws were inspected and there did not appear to be any evidence of hardware failure or damage. The shoulder was ranged under fluoroscopy and the ribboned strand did not appear to be intraarticular. The threads of the unraveled screw were past the fracture site and we felt we had adequate fixation and decided to leave it in place. At the patient's two-week follow-up, a repeat x-ray was performed and no screw migration or fracture displacement was noted.

The mechanism of the screw unwinding has been thought to be due to weakness that develops at the self-cutting flute that propagates along the screw as the screw is inserted^[3]. Previous case reports have cited catching on dense cortical bone which lead to the screw unwinding^[1,4,5].

Fig 2: AP of the right shoulder showing the lateral screw unravelling

What is unusual in our case is that our screw unraveled in cancellous bone in a patient with advanced age. It has been postulated that pre-drilling and pre-tapping prior to insertion may be a way of preventing this complication ^[4].

This case represents a nuance in a previously established problem with the cannulated partially threaded cancellous screws. Given that our screw unraveled in elderly, cancellous bone, it may be prudent to pre-drill and tap prior to insertion of any screw or perhaps further manufacturer investigation into the integrity of the screw is warranted.
