International Journal of Case Reports in Orthopaedics

IJCRO 2021; 3(1): 91-92

Unwinding of a 4.5 mm partially threaded cannulated screw in an elderly patient: A case report

Case: An elderly patient sustained a base of the coracoid fracture with superior clavicle migration requiring open reduction internal fixation. When inserting our 4.5 mm partially threaded cannulated screw, it began to unravel revealing an underlying screw defect.

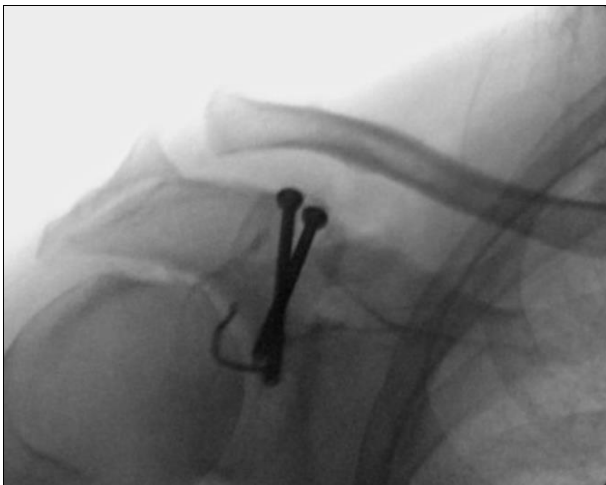
The mechanism of the screw unwinding has been thought to be due to weakness that develops at the self-cutting flute that propagates along the screw as the screw is inserted^[3]. Previous case reports have cited catching on dense cortical bone which lead to the screw unwinding^[1,4,5].

Fig 2: AP of the right shoulder showing the lateral screw unravelling

This case represents a nuance in a previously established problem with the cannulated partially threaded cancellous screws. Given that our screw unraveled in elderly, cancellous bone, it may be prudent to pre-drill and tap prior to insertion of any screw or perhaps further manufacturer investigation into the integrity of the screw is warranted.
