International Journal of Case Reports in Orthopaedics

One block arthroscopic removal of a loosened glenoid component after total shoulder arthroplasty

Mahieu Xavier, Berger Johanna and Crahay Arnaud

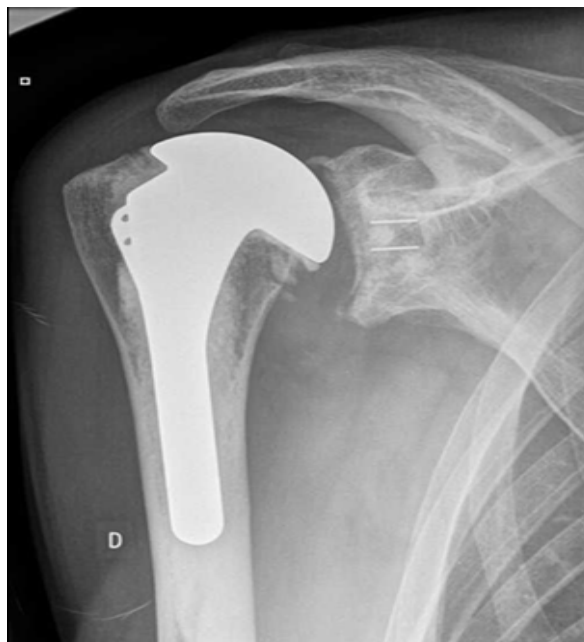
Fig 1: Post-operative X-ray of the shoulder after total shoulder arthroplasty, showing no radiolucencies or loosening of the glenoid component

A 56-year-old butcher patient who had underwent total shoulder arthroplasty at another hospital was referred at two years prior to his arthroscopy. The initial clinical history and examination showed the following details. The patient had been satisfied with the surgical outcome for one year after TSA (Figure 1). He sustained a fall with a trauma to the right shoulder and started to complain about a painful shoulder. The clinical examination showed a slightly less functional shoulder with decreased range of motion as compared with the non-operated left-side. The patient underwent X-rays, ultrasound, tomography, scintigraphy during his follow-up in our institution. Pain did not decrease during the follow-up period, on the contrary it increased. Basic laboratory work-up (complete blood count, erythrocyte sedimentation rate, C-reactive protein) and joint aspiration were negative.

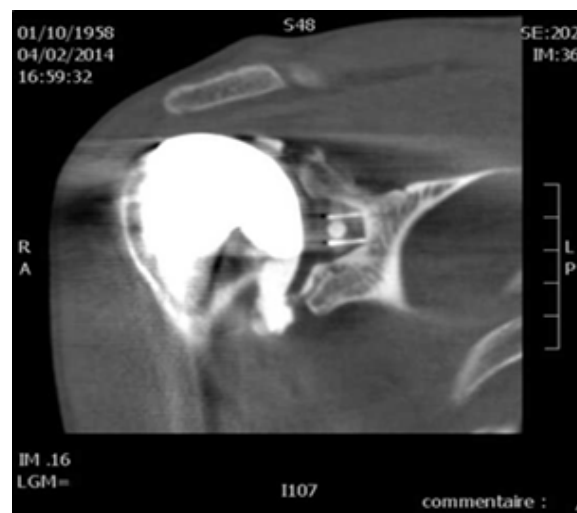
Fig 2: Arthro-CT scan suggesting possible glenoid component loosening in the patient's shoulder

The X-rays were compared with earlier plain radiographs and showed no periprosthetic radiolucencies compared with the initial post-operative X-rays. The arthro-CT scan suggested possible glenoid component loosening (Figure 2).

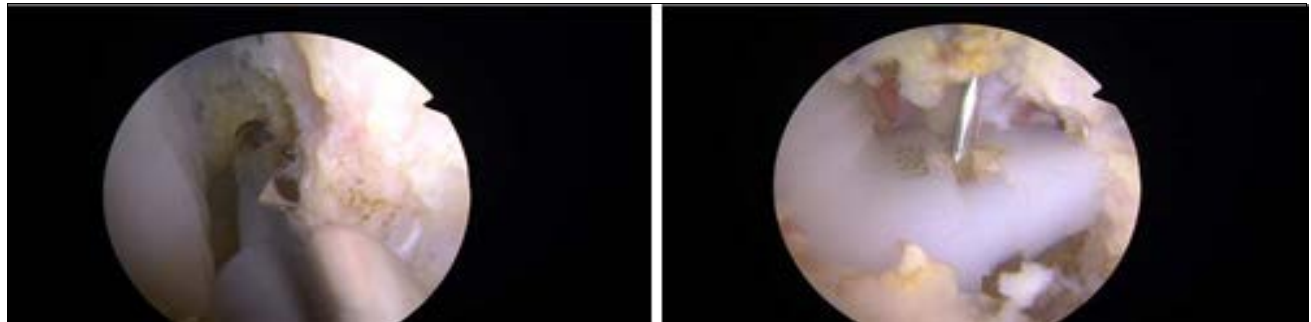
Fig 4a: Drill being used to clear cement from the hole in the keel of the glenoid component during arthroscopic surgery.

Fig 4b: A 1.5mm stainless steel wire passed through the hole in the keel of the glenoid component, grasped through the anterior portal.

In this case, the Aequalis glenoid component (Tornier, Montbonnot Saint Martin, France) has a native hole in the middle of the keel, made for cement fixation purpose. This

native hole was filled in with cement and a drill was used to clear the hole from cement (Figure 4a).

Then, using a Neviaser portal located on the superior part of the shoulder, a 1.5mm stainless steel wire was introduced in the joint and passed through the hole of the keel and then grasped through the anterior portal (Figure 4b). The superior extremity of the wire was then pulled and bent in the joint so that both ends of the wire, catching the glenoid keel, could be pulled out through the rotator-cuff interval after small additional opening of the skin (Figure 5a). Finally, a shaver and curette were used to remove the remaining cement and ream the bone of the glenoid cavity to make it bleed (Figure 5b).

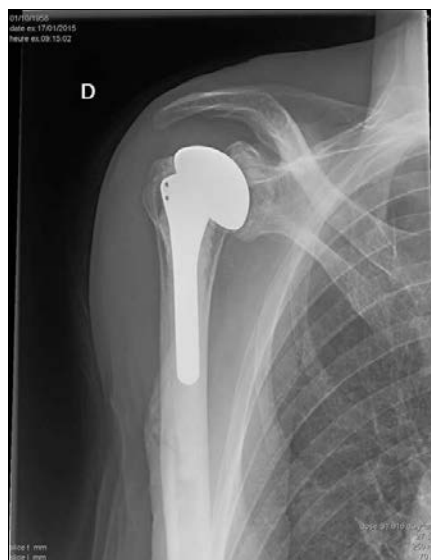
Fig 6: Post-operative image showing the patient's shoulder with no perioperative complications after the arthroscopic removal of the glenoid component

The arthroscopic removal of the glenoid was a technical success. The patient was discharged the day after surgery (Figure 6). A sling was worn during 3 weeks and he then started physiotherapy. There were no operative or perioperative complications.
