Dislocation of the polyethylene insert following fixed-bearing total knee arthroplasty: A case report

Abstract

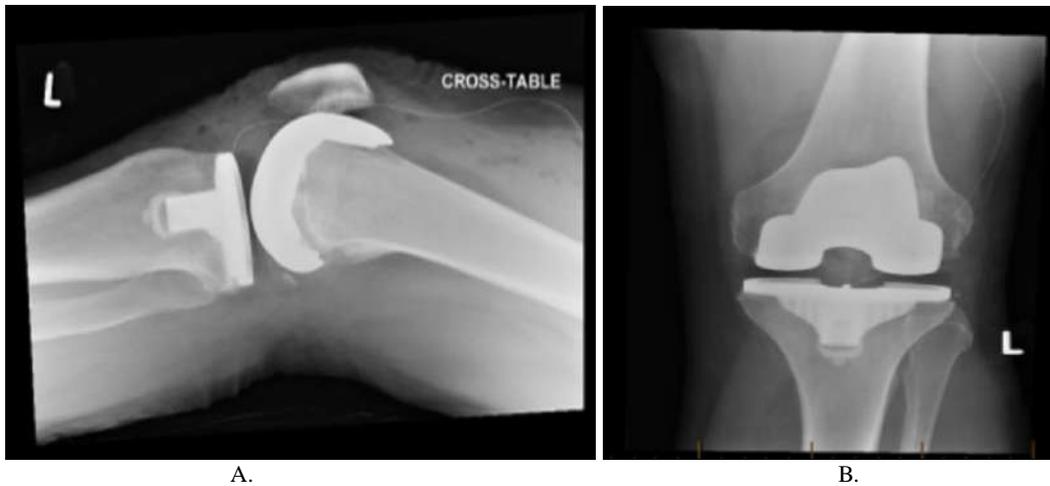
Fig 1: Radiographs in cross-table and anterior views after the initial TKA showing a well located polyethylene liner

This case involves a 62 year old gentleman who suffered from left knee osteoarthritis subsequent to a football injury dating back to 1980. He initially coped well following a meniscectomy. However, he developed progressive increased pain over the course of five years which limited his ability to perform his activities of daily living. He subsequently underwent a TKA in 2018 using a Physica posterior stabilised (PS) system with a size 9 cemented tibia component, size 8 cemented femoral component, size 9 #12 tibia PS liner and a 35mm x 8.5mm cemented patellar prosthesis [Figure 1]. His intraoperative knee range of motion on table was 0-150 degrees with stability achieved throughout the entire range and the polyethylene implant was securely fixed to the tibial tray without soft tissue, bone or cement interference. His postoperative recovery was unremarkable.

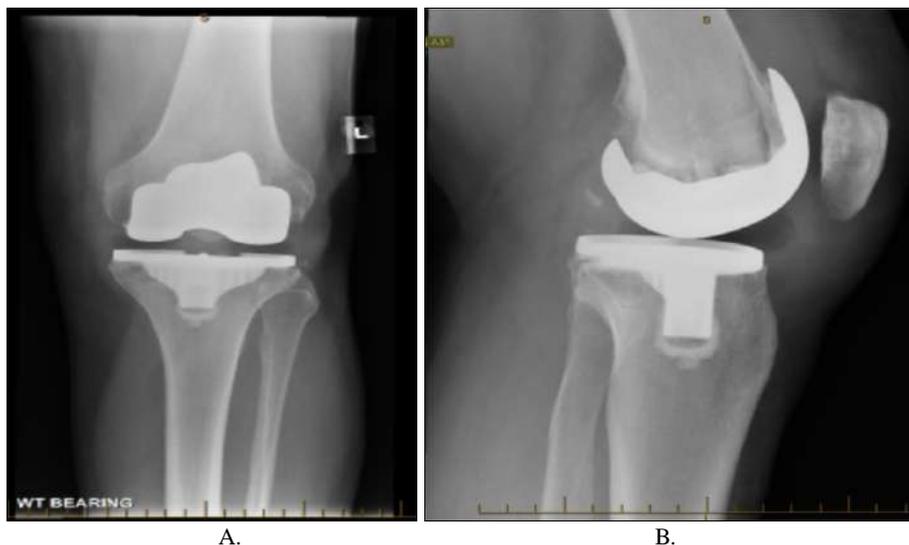
Fig 2: Radiographs in lateral and anterior views showing anterior dislocation of the polyethylene liner

Three months after his TKA he fell on the stairs at a concert leading to a hyperflexion injury where he “felt something go” inside his knee. Following this his knee became completely unstable and x-ray imaging showed dislocation of his polyethylene liner [Figure 2]. He was taken to the operating theatre and a clearly dislocated liner was identified. Macroscopically there was deformation of the medial trough, seemingly normal posterior grooves and a smaller anterior groove for the locking mechanism. There was no evidence of soft tissue or cement on the tibial tray and the tray itself appeared normal. The anterior flange measured 18.46mm wide, 2.02mm high and 0.8mm deep [Figure 3]. Upsizing of the trial revealed a lack of extension and so a new size 9 #12 PS liner was reinserted. This again displayed good stability throughout the entire range of motion. He had an unremarkable post-operative recovery and two years down the line is able to achieve 0-140° motion with no concerns [Figure 4].

It is of our opinion that our patient had significant enough posterior load during his hyperflexion injury to lift off the anterior rim causing sudden dislocation of the liner. In this case we checked at the time of initial surgery that the liner was seated properly, post-operative x-ray imaging showed normal positioning and he was symptom free until his injury. Furthermore, at revision there was no bone, soft tissue or cement identified that could have impinged on the tibial tray. Therefore we believe dislocation occurred in the setting of a normal, well positioned liner. In this case we postulate that the large, size 9 implant, coupled with the small anterior flange of the Physica implant design predisposed to anterior dislocation from excessive posterior force experienced during a fall causing hyperflexion and loading of the knee.

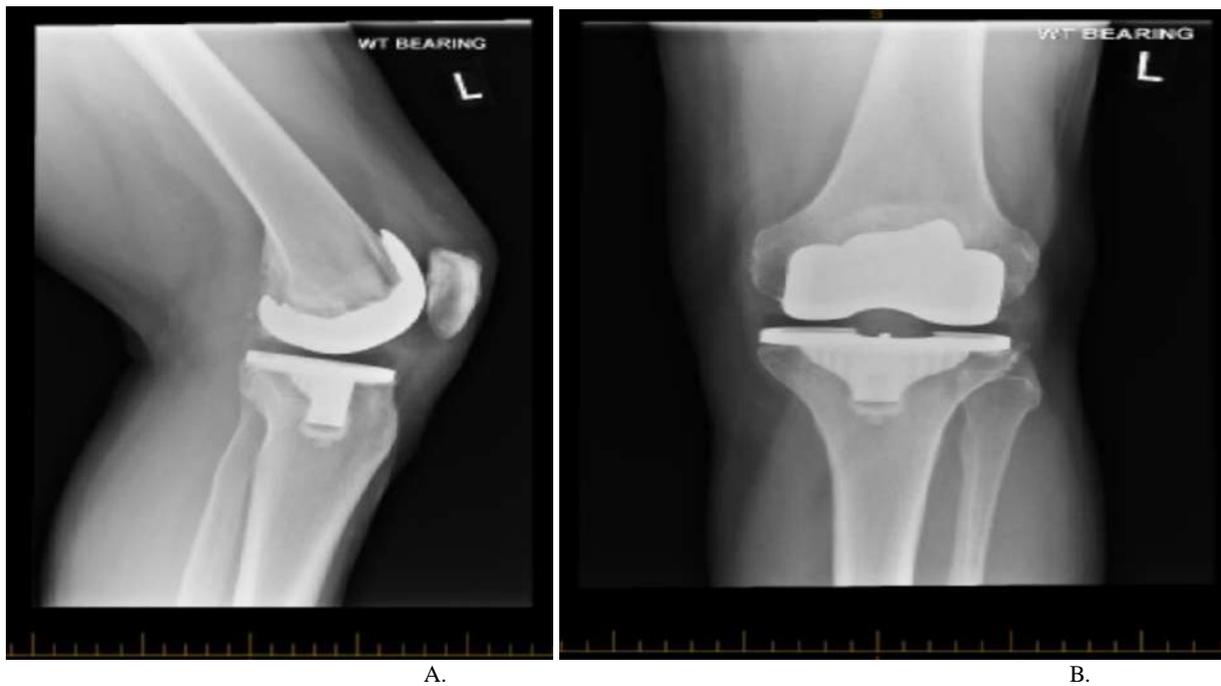
Fig 4: Post-revision radiographs in lateral and anterior views showing a well located polyethylene liner.

In cases of dislocation revision surgery is recommended. In our patient, replacement of the liner alone provided good results however some reports of spontaneous dislocation have shown an association with weakening of the locking system [5]. In these cases revision of the tibial component as well as the liner is indicated.
