IJCRO 2021; 3(1): 91-92

Unwinding of a 4.5 mm partially threaded cannulated screw in an elderly patient: A case report

Michael Booth MD and George Bal MD

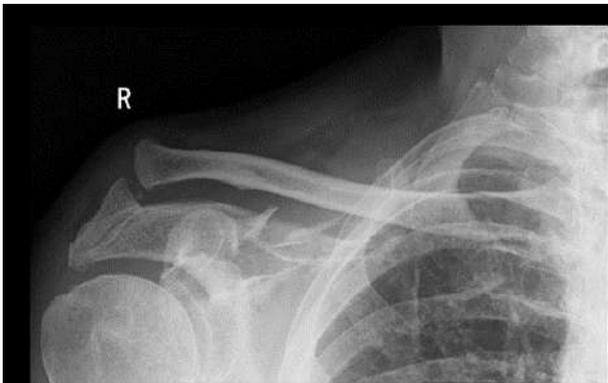
A 71-year-old right hand dominant old male sustained a right displaced coracoid fracture after a tree fell onto his shoulder (figure 1). Given the amount of displacement at the base of the coracoid, superior migration of the clavicle and the increased pain the patient was experiencing, he elected to proceed with an ORIF of his coracoid.

Fig 1: X-ray of the right shoulder showing a displaced coracoid fracture with superior migration of the clavicle
