International Journal of Case Reports in Orthopaedics

IJCRO 2021; 3(1): 91-92

Unwinding of a 4.5 mm partially threaded cannulated screw in an elderly patient: A case report

Case: An elderly patient sustained a base of the coracoid fracture with superior clavicle migration requiring open reduction internal fixation. When inserting our 4.5 mm partially threaded cannulated screw, it began to unravel revealing an underlying screw defect.

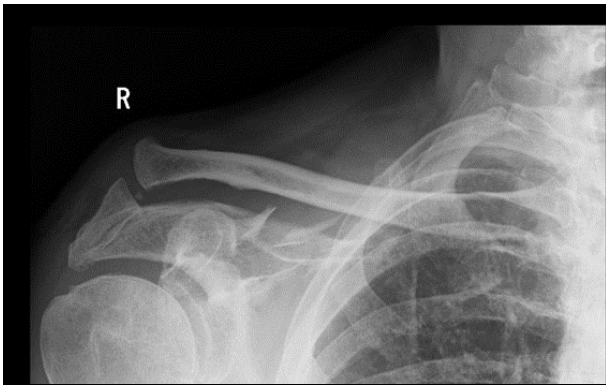
A 71-year-old right hand dominant old male sustained a right displaced coracoid fracture after a tree fell onto his shoulder (figure 1). Given the amount of displacement at the base of the coracoid, superior migration of the clavicle and the increased pain the patient was experiencing, he elected to proceed with an ORIF of his coracoid.

Fig 1: X-ray of the right shoulder showing a displaced coracoid fracture with superior migration of the clavicle
